APPENDIX B

MERRIMACK RIVER WATERSHED

I. WATERSHED DESCRIPTION AND MAPS

B1: Colony Beach, Locke Lake, Barnstead, NH

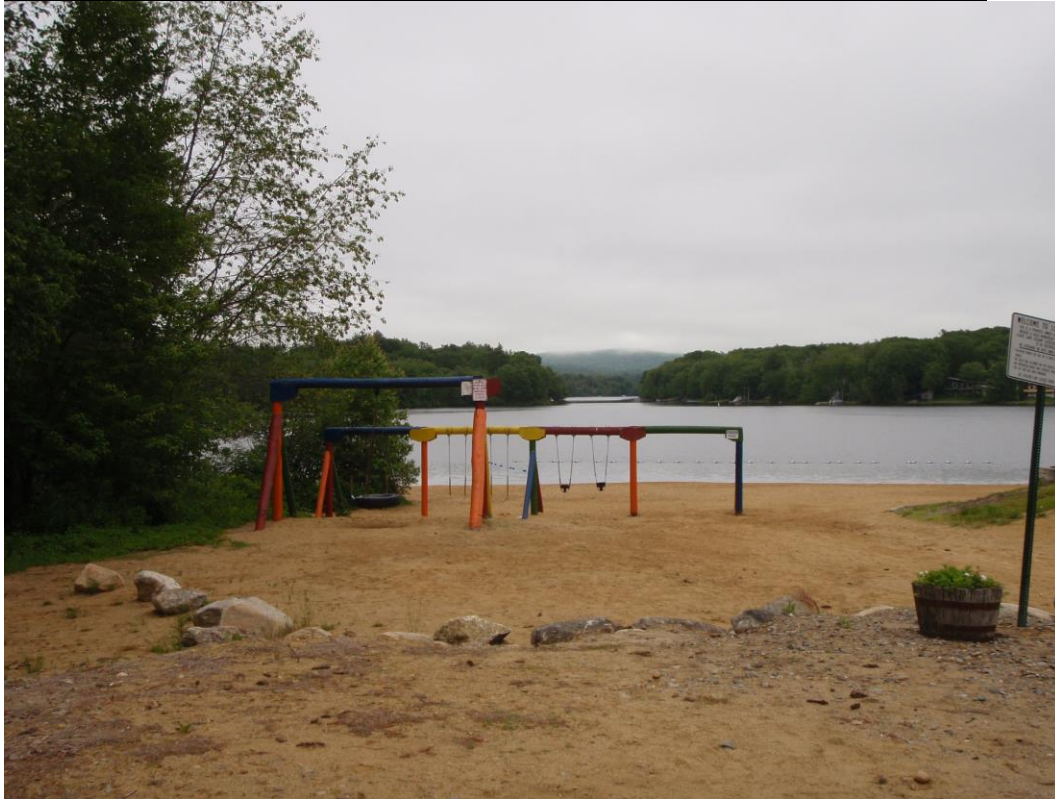
Figure 2: Photo of Colony Beach, located on the west end of Locke Lake

Bacterial contamination of surface waters may result from a variety of sources including human waste, excrement from barnyard animals, pet feces, and agricultural applications of manure and wildlife, including large congregations of birds and small mammals. Based on visual reconnaissance conducted by DES in 2015, recommended actions to reduce bacteria levels at Colony Beach (which have been successfully employed at other New Hampshire beaches) include measures to deter geese (such as installation of trumpeter swan and coyote decoys – see the DES Fact sheet¹), collection of scat from the beach and wading areas and posting signs to deter feeding wildlife. Following implementation, monitoring for *E. coli* should continue to determine if the restoration measures are sufficient to meet water quality standards or if additional restoration activities are necessary.

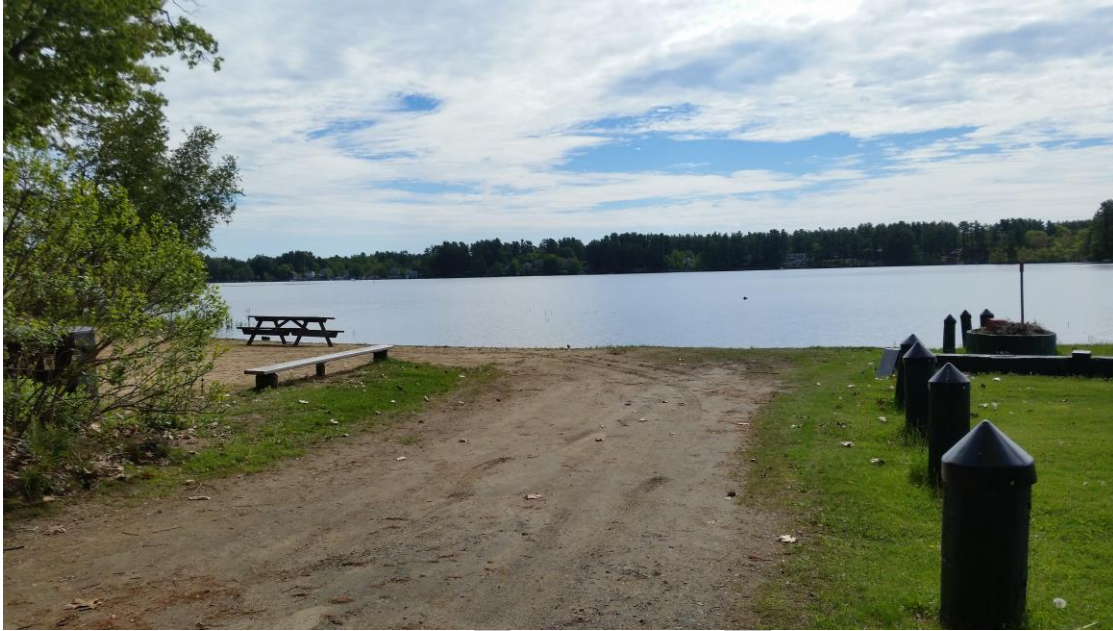
Figure 4: Park Association Beach Photo

On May 21st 2015, staff from the DES TMDL Program and the Beach Monitoring Program met on site with the Great Pond Park Beach (also known as 5th Street Beach) Association Members and Landowners Richard Coleman and Bob Sullivan. Mr. Coleman is also the Volunteer Lake Assessment Program (VLAP) monitor at the beach. We discussed the development of the TMDL Report, reviewed the sampling data from the beach swimming area used to develop the TMDL report and discussed information on what/where the potential source(s) of bacteria might be in that area. There were no stormwater/road runoff areas apparent, no history or evidence of failing septic systems in the area (the lake association provides a restroom facility at the beach area during the

summer) and there is no history of issues with pet waste in the beach area. There is, however, an area of lawn directly adjacent to the beach with a large marsh/wetland area beyond the footprint of lawn. Waterfowl (geese) however, have been seen on the lawn and in and around the roped off swimming area for the beach. Information on deterring the presence of waterfowl such as swan decoys and planting brush along the shoreline, was discussed with the landowners. These and other geese deterrent measures are described in the DES Fact Sheet². Implementation of measures such as these have proven successful at other beaches in New Hampshire and it is recommended that similar waterfowl deterrent measures be implemented at Great Pond Beach as a first step. Following implementation, monitoring for *E. coli* should continue to determine if the restoration measures are sufficient to meet water quality standards or if additional restoration activities are necessary.
